Laser-Induced Damage Threshold (LIDT) Measurement Report

ISO 21254-2: S-on-1 Test Procedure

Sample: 2-CPW-ZO-L/2-0343

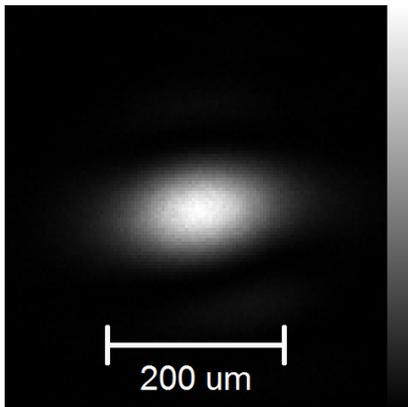
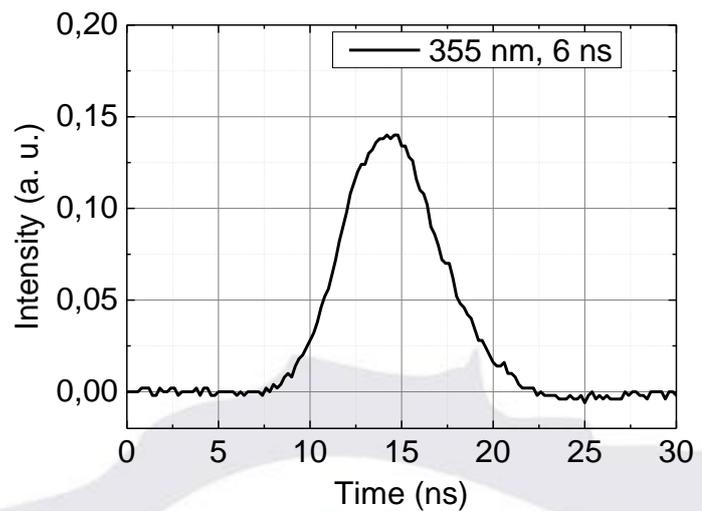
Fig. 1 Spatial beam profile in target plane (left) and oscilloscope trace (right)

Wavelength: 355 nm
Angle of incidence: 0 deg.
Polarization state: linear
Pulse repetition frequency: 100 Hz
Spatial beam profile in target plane: TEM₀₀
Longitudinal beam profile: Single mode (SLM)
Beam diameter in target plane ($1/e^2$): 180.5 μ m (average from 64 pulses)
Pulse duration: 6 ns

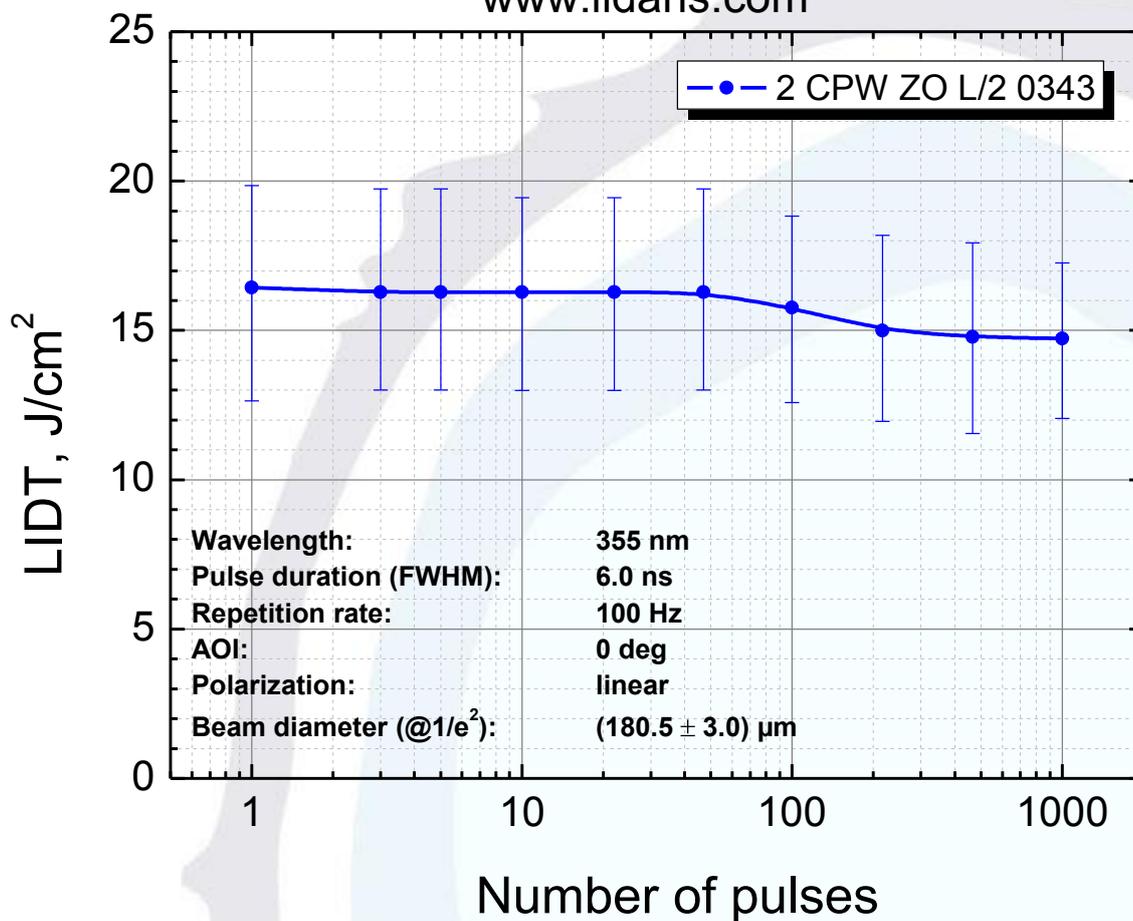
Fig. 2 Characteristic damage curve.

Table 1 Summarized LIDT's for 2-CPW-ZO-L/2-0343

Test mode	Threshold, J/cm ²
1-on-1	12.63 ≤ 16.43 ≤ 19.84
1000-on-1	12.05 ≤ 14.73 ≤ 17.26
