# LASER-INDUCED DAMAGE THRESHOLD (LIDT) MEASUREMENT REPORT

S-ON-1 (ISO 21254-2)  
TEST PROCEDURE

Sample: 72668 kaitintas

Name	72668 kaitintas
Type	HR Dielectric Coating (HR (Rs>99,9%, Rp>99,7%) @ 343-355 nm, AOI 45°)
Dimensions	Ø25.4 x 5.0 mm
Packaging	Plastic box

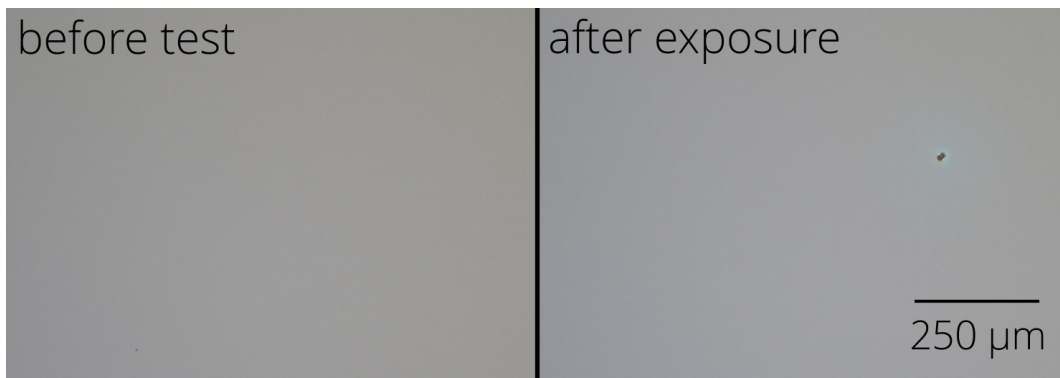
Figure 5. Typical damage morphology: fluence  $12.1 \text{ J/cm}^2$ , damage after 28 pulse(s).
