Laser-Induced Damage Threshold (LIDT) Measurement Report

ISO21254-2: S-on-1 Test Procedure

Tester/date: M. Sciuka / 2015-10-08

Name of sample: HRs>99,5%@750-850nm, AOI=45 deg.

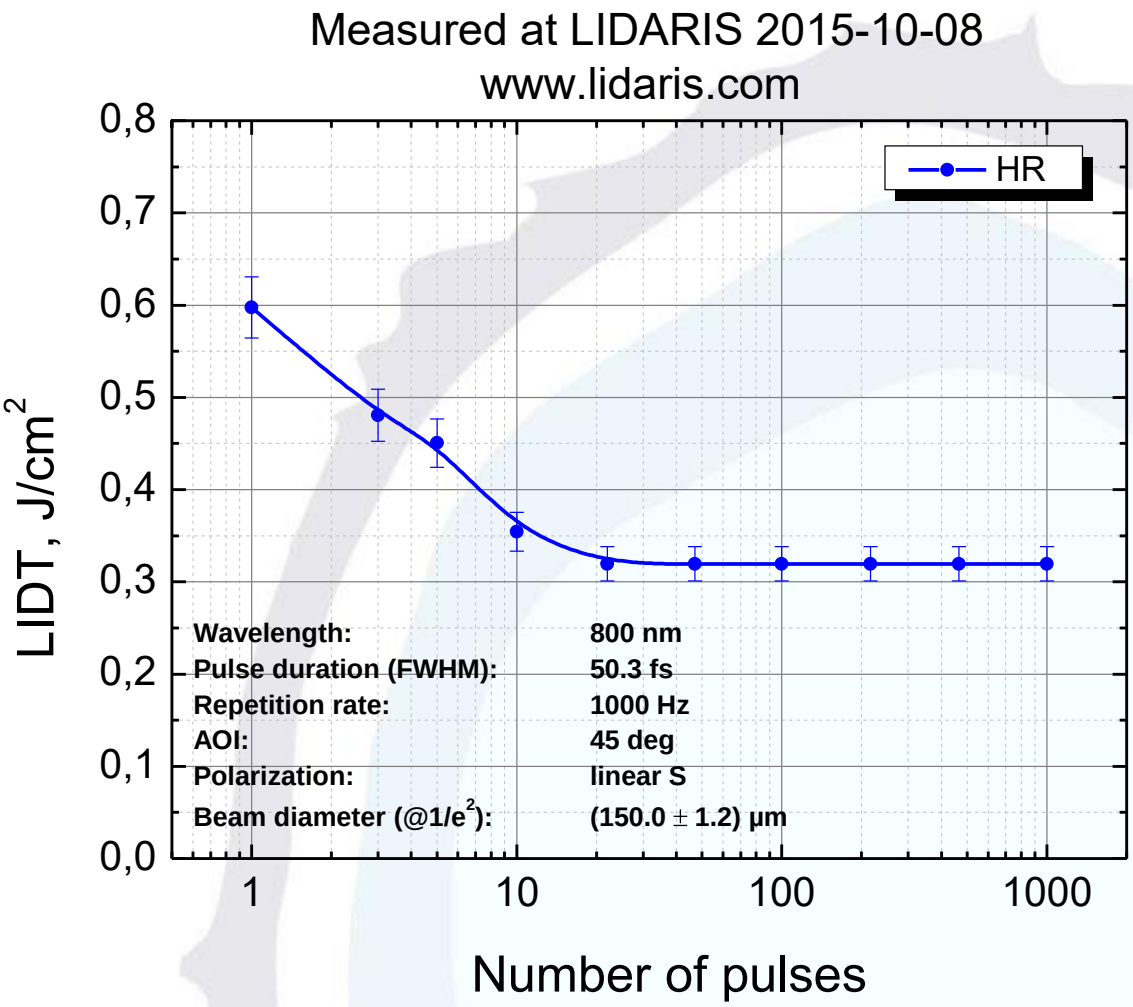
Test mode	Threshold, J/cm^2
1-on-1	0.60 ± 0.03
1000-on-1	0.32 ± 0.02

Fig. 3. Characteristic damage curve.

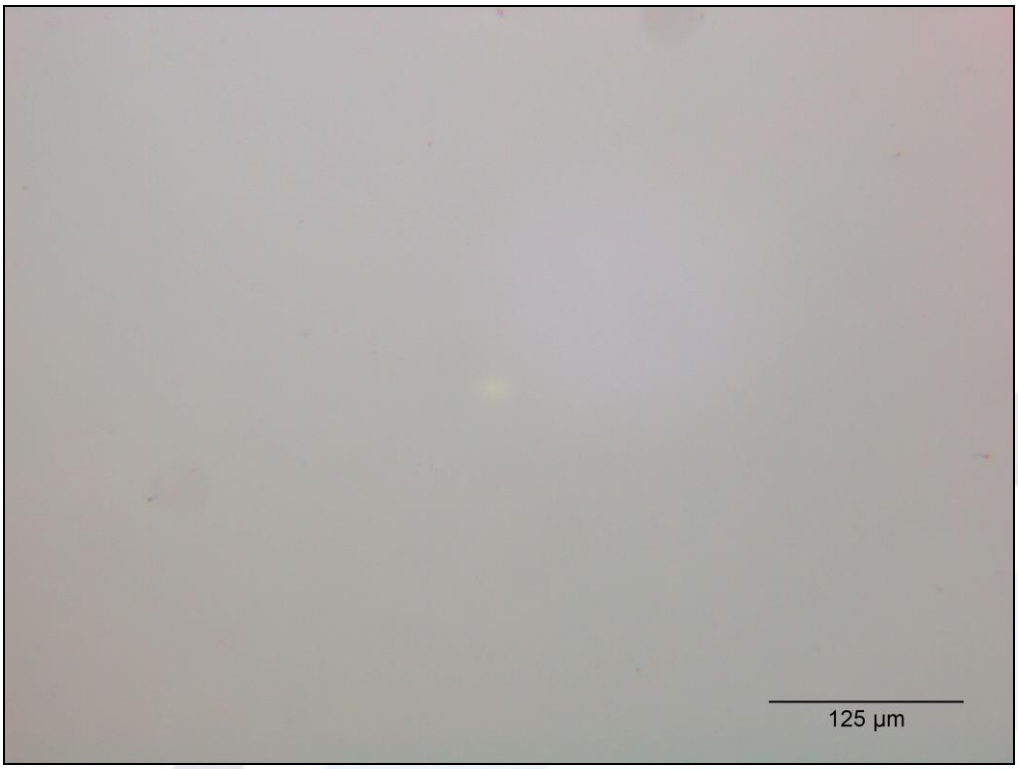
Fig. 4. Typical front surface damage morphology
(Fluence 0.62 J/cm^2, damage after 1 pulse)

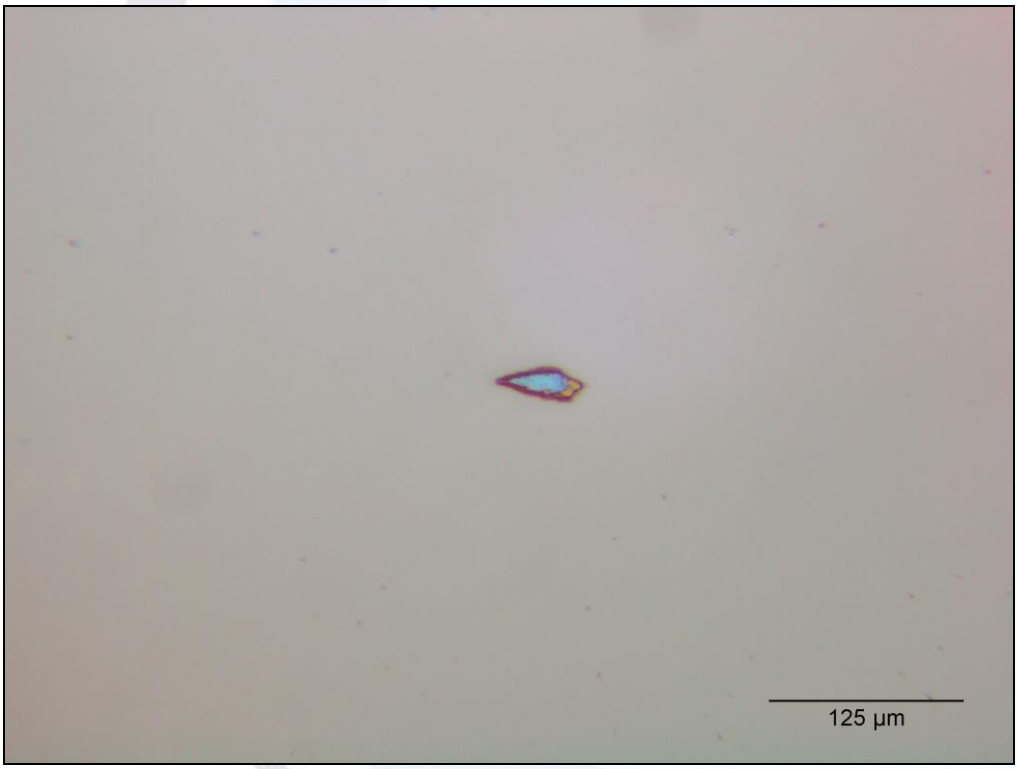
Fig. 5. Typical front surface damage morphology
(Fluence 0.32 J/cm^2, damage after 1000 pulses)
