LASER-INDUCED DAMAGE THRESHOLD (LIDT) MEASUREMENT REPORT

S-ON-1 (ISO 21254-2) TEST PROCEDURE

Sample: 72668 kaitintas

Name	72668 kaitintas
Type	HR Dielectric Coating (HR (Rs>99,9%, Rp>99,7%) @ 343-355 nm, AOI 45°)
Dimensions	Ø25.4 x 5.0 mm
Packaging	Plastic box

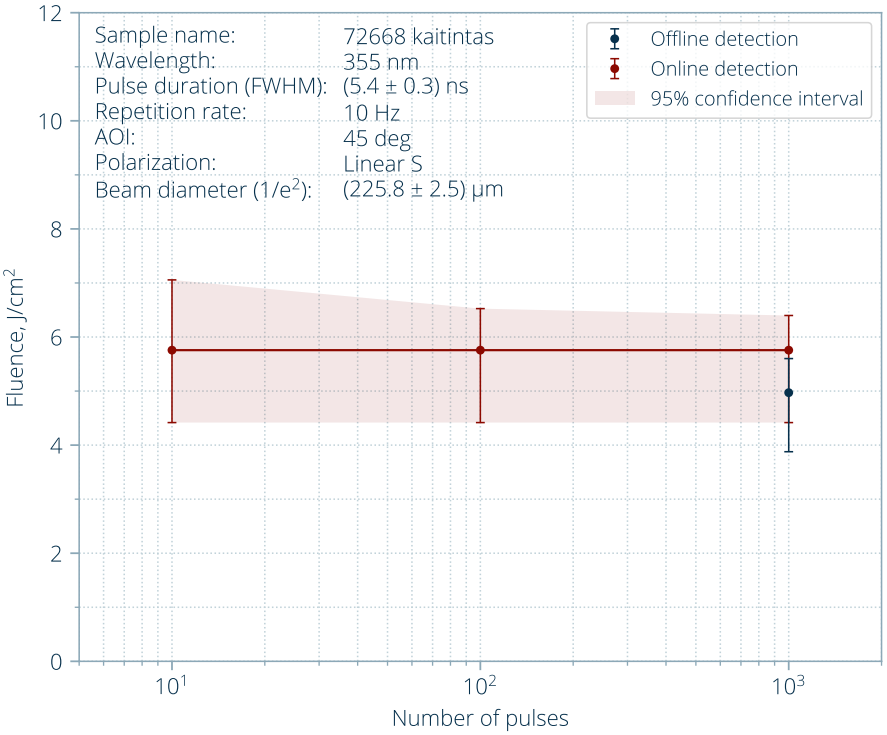
Figure 2. Characteristic damage curve.

10^3-on-1	$4.97\ ^{+0.63}_{-1.09}$ J/cm^2

Table 1: Estimated LIDTs from fiting model for sample 72668 kaitintas.

Test mode	Threshold (Offline detection - microscopy)	Threshold (Online detection - scattering)
10-on-1	-	$5.76\ ^{+1.30}_{-1.34}$ J/cm^2
10^2-on-1	-	$5.76\ ^{+0.77}_{-1.34}$ J/cm^2
10^3-on-1	$4.97\ ^{+0.63}_{-1.09}$ J/cm^2	$5.76\ ^{+0.64}_{-1.34}$ J/cm^2

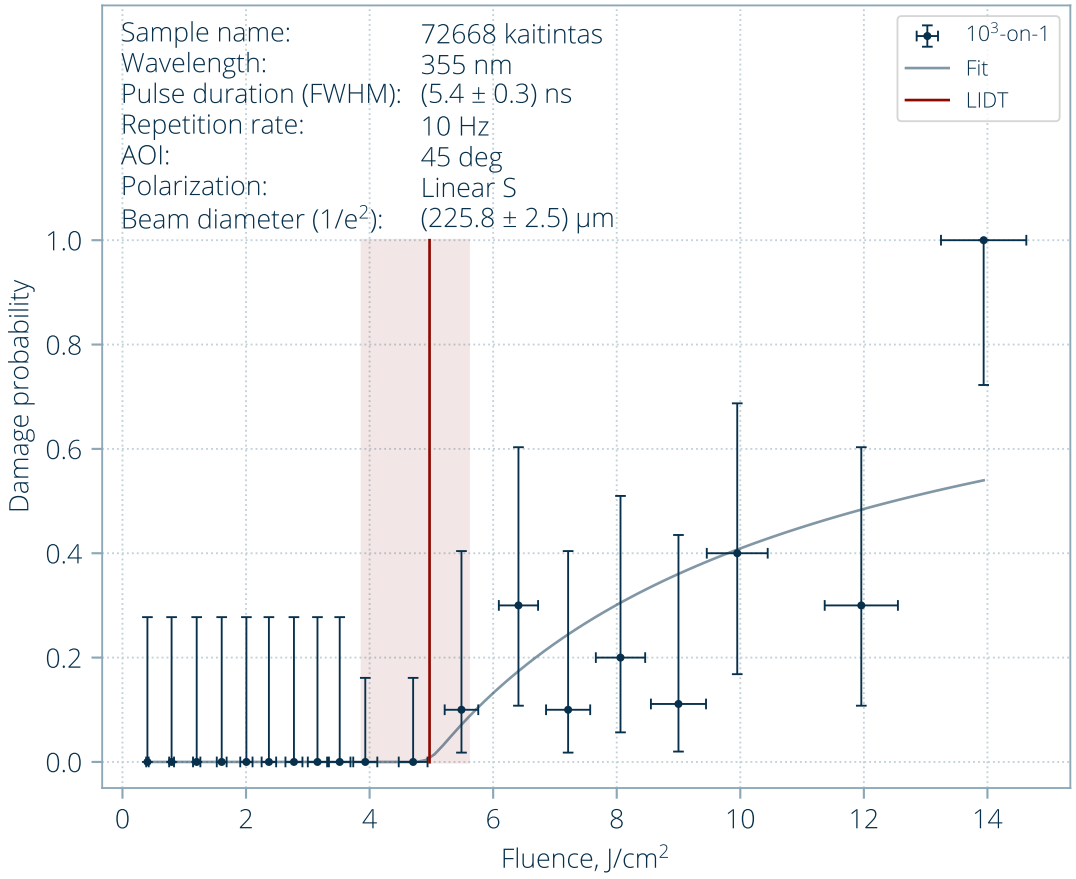
Figure 3. Damage probability plot.

(a) 10^3-on-1

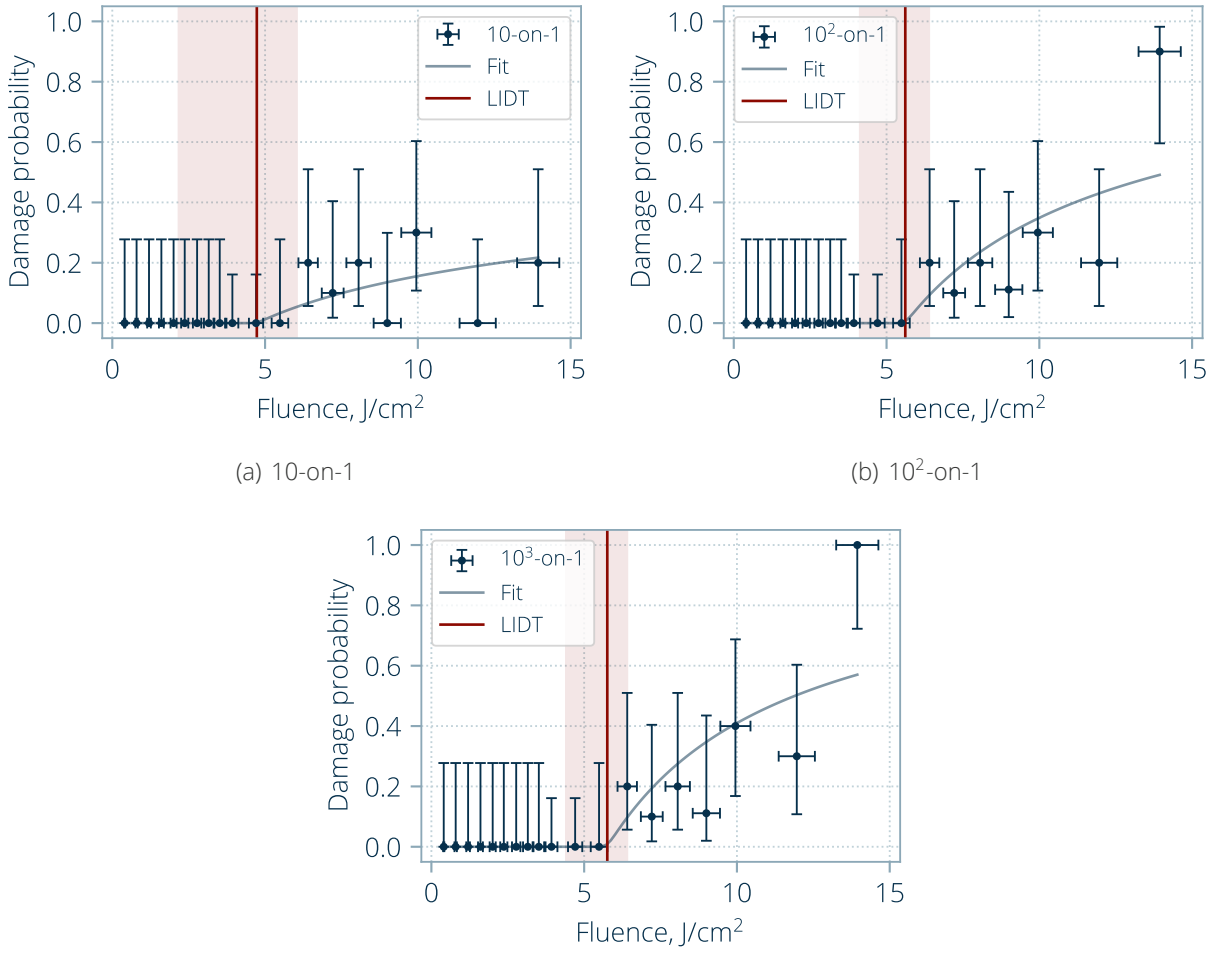
Figure 6. Damage probability plots.

(a) 10-on-1

(b) 10^2-on-1

(c) 10^3-on-1
